**TRANSPORTATION SCIENCES CENTER
ACCIDENT RESEARCH GROUP**

**CALSPAN ON-SITE AIR BAG DEPLOYMENT INVESTIGATION
CALSPAN CASE NO. 94-14
VEHICLE: 1994 OLDSMOBILE NINETY EIGHT REGENCY ELITE
LOCATION: [REDACTED]
CRASH DATE: [REDACTED], 1994**

14. Sponsoring Agency Code	
15. Supplementary Notes On-site investigation of an air bag deployment crash that resulted in multiple fractures to the right hand of the right front passenger of a 1994 Oldsmobile Ninety Eight as she attempted to brace against the air bag module cover flap.

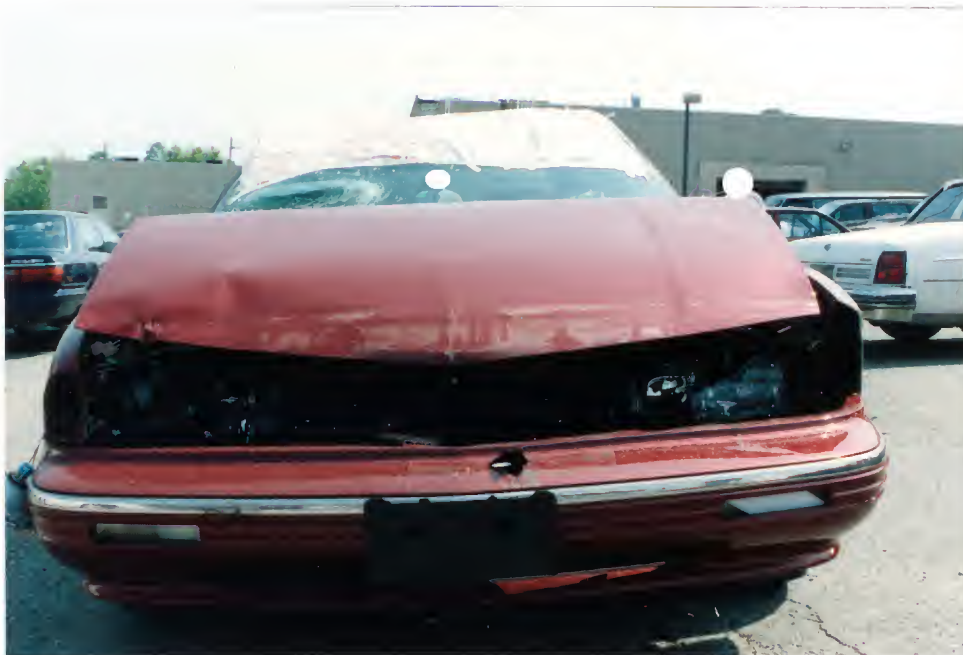
The 1994 Oldsmobile Ninety Eight sustained moderate frontal damage as a result of its front-to-rear impact sequence with the stopped Ford Ranger (vehicle #2). In an attempt to avoid the crash, the driver of the Oldsmobile applied a braking force which compressed the front suspension as the vehicle impacted the rear of the stopped Ford Ranger. The top surface of the front bumper fascia initially impacted then underrode the rear step bumper of the pickup truck. Damage to the fascia consisted of longitudinally oriented abrasions to top surface and a tear located 7.6 cm (3.0") left of the center that resulted from the trailer hitch stud protruding from the center of the rear bumper of the Ford Ranger. The center-mounted license plate frame was cracked as a result of the contact sequence. There was compression of the bumper energy absorbing devices (EADs) and no residual crush at bumper level. Both front bumper EADs remained in their original pre-crash position at 8.6 cm (3.375") in length (refer to Photograph Nos. 15 and 16). As the front bumper of the Oldsmobile underrode the rear bumper of the Ford Ranger, the grille and hood face area engaged against the bumper face and tailgate of the Ford Ranger. The direct contact damage was 140.0 cm (55.1") in length which extended across the entire width of the vehicle at grille level. The contact fractured the plastic grille and headlamp assemblies and deformed the air conditioning condenser, the center mounted air bag discriminating sensor, and the upper radiator support panel. Maximum crush was 25.1 cm (9.875") located at the radiator support panel 38.1 cm (15.0") left of center (refer to Photograph Nos. 13 and 14). The residual crush profile was documented at the upper radiator support level and was as follows: $C_1 = 9.1$ cm (3.6"), $C_2 = 24.4$ cm (9.6"), $C_3 = 19.7$ cm (7.75"), $C_4 = 16.8$ cm (6.6"), $C_5 = 14.2$ cm (5.6"), $C_6 = 2.3$ cm (0.9"). The leading edge of the hood sustained contact damage from engagement with the tailgate of the struck Ford Ranger. The contact damage began 12.1 cm (4.75") inboard of the right corner and extended 134.6 cm (53.0") to the left corner (refer to Photograph No. 7). The tempered glass sunroof separated from the vehicle and was found lying undamaged in the rear seat area of the vehicle. The roof sustained symmetrical areas of deformation directly rearward of the B-pillars on both sides of the vehicle (refer to Photograph Nos. 21 and 26).

6. Frontal damage to the Oldsmobile 98.

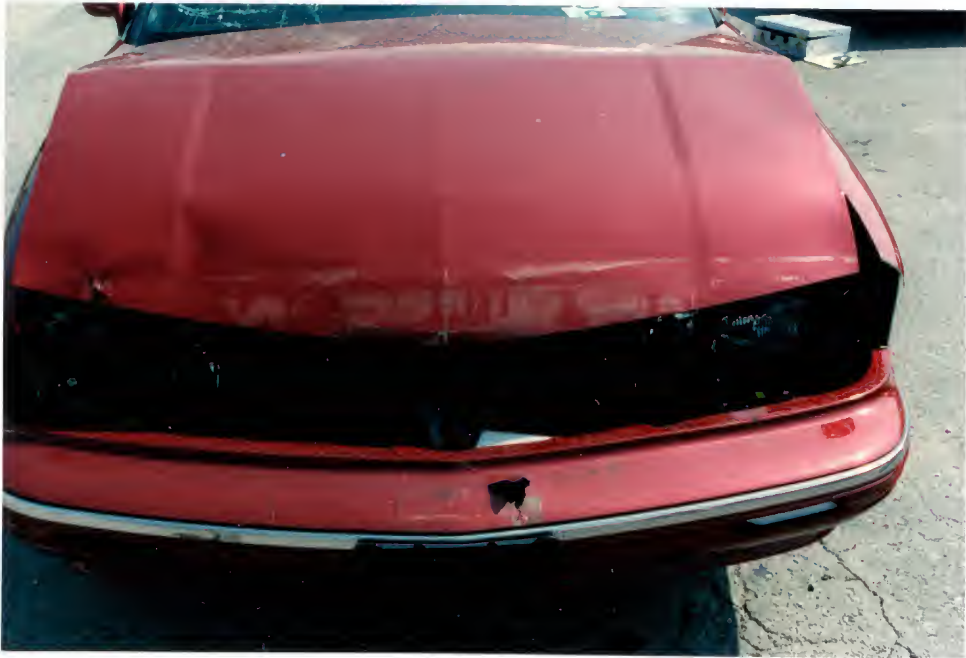
The front suspension of the Oldsmobile probably compressed due to the pre-crash braking as it impacted the rear of the stopped Ford Ranger. The top surface of the front bumper facia initially impacted then underrode the rear step bumper of the pickup truck. There was abrasive type damage to the top surface of the facia, however, there was no residual crush at bumper level or compression of the bumper energy absorbing devices (EADs). The grille, hood face, and upper radiator support of the Oldsmobile subsequently engaged against the bumper and tailgate of the Ford Ranger. The contact sequence fractured the plastic grille and headlamp assemblies and crushed the radiator support to a maximum depth of 25.1 cm (9.9") located 38.1 cm (15.0") left of center. The Collision Deformation Classifications (CDC) were 12-FDMW-1 and 06-BDEW-1 for the Oldsmobile and the Ford Ranger respectively. The damage algorithm of the CRASHPC program computed velocity changes of 16 km/h (10 mph) for the Oldsmobile and 21 km/h (13 mph) for the Ranger. As a result of the impact induced deployment, the Oldsmobile Ninety Eight's driver and passenger side air bags deployed.

7. Direct contact damage across top surface of bumper fascia and hood.

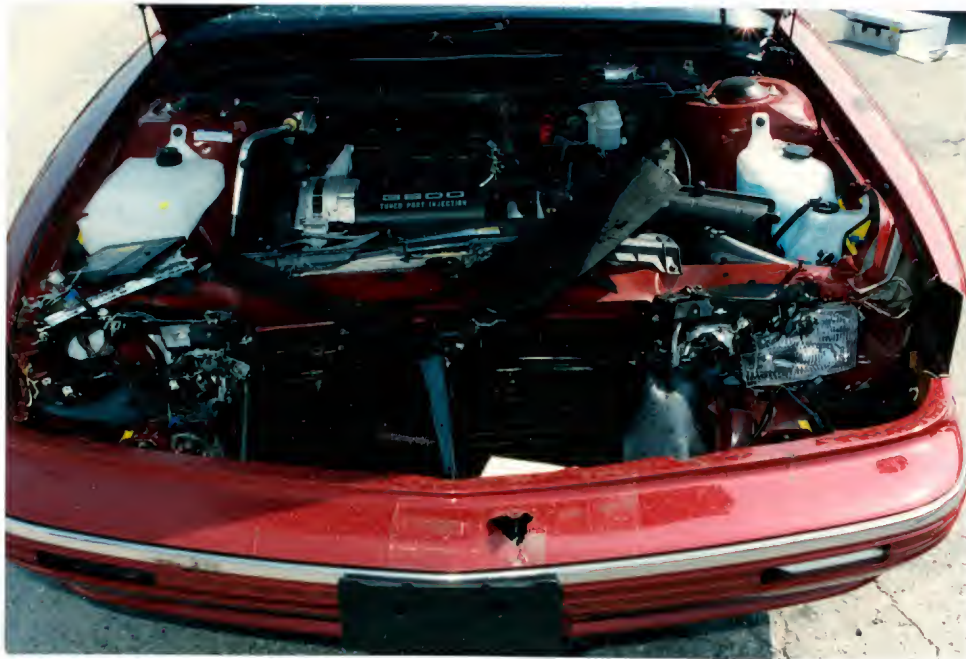
8. Damage across grille and upper radiator support.

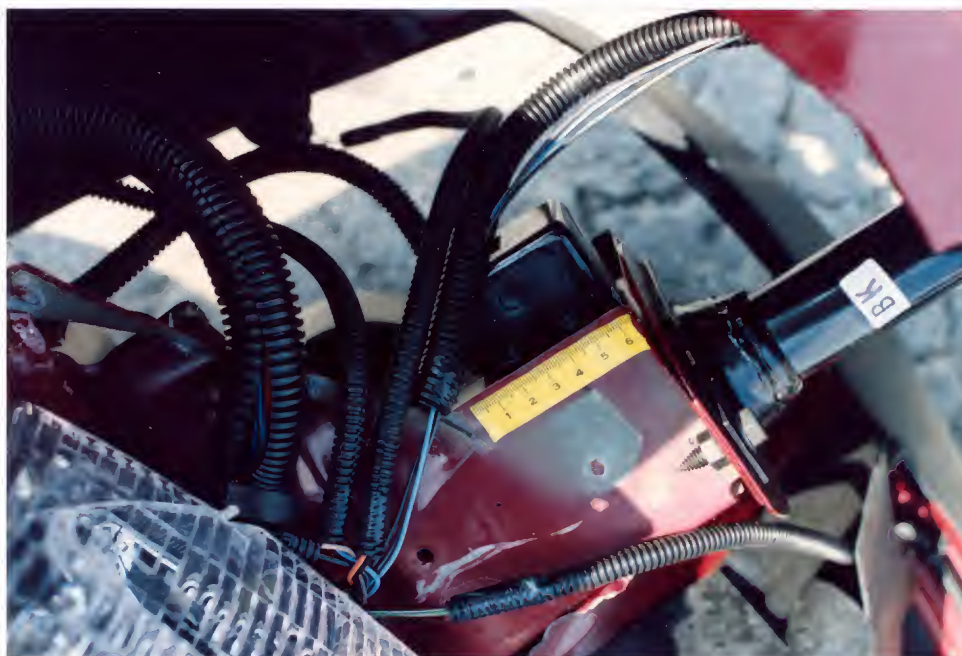
The two outboard discriminating sensors were mounted to the frame rails directly rearward of the bumper EADs (refer to Photograph Nos. 17 and 19). The third discriminating sensor was mounted to the forward side of the radiator support panel, adjacent to the left side of the hood latch assembly. The forward aspect of the center mounted sensor was slightly deformed as a result of the frontal impact (refer to Photograph No. 18), however, the deformation did not appear to have damaged the internal components of the sensor.

17. Left front discriminating (crash) sensor.

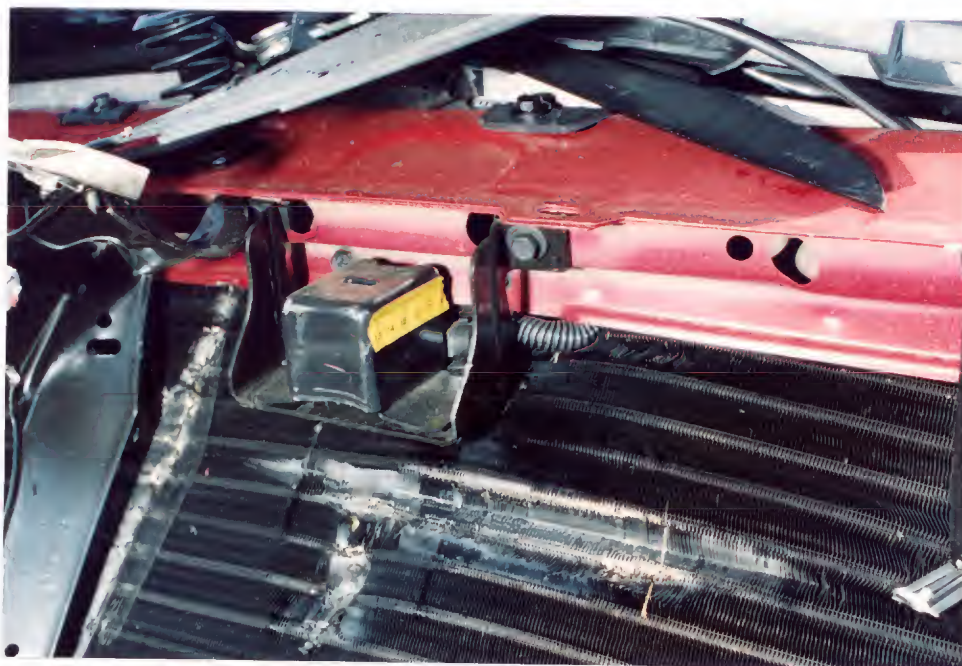
18. Contact damage to the leading edge of the center front discriminating sensor.

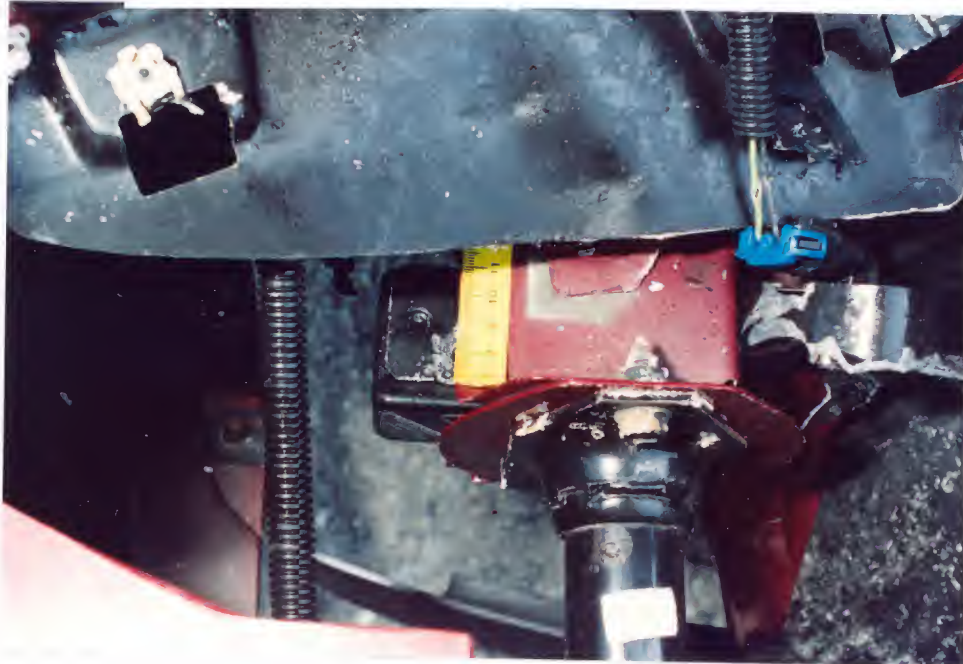
19. Right front discriminating sensor.

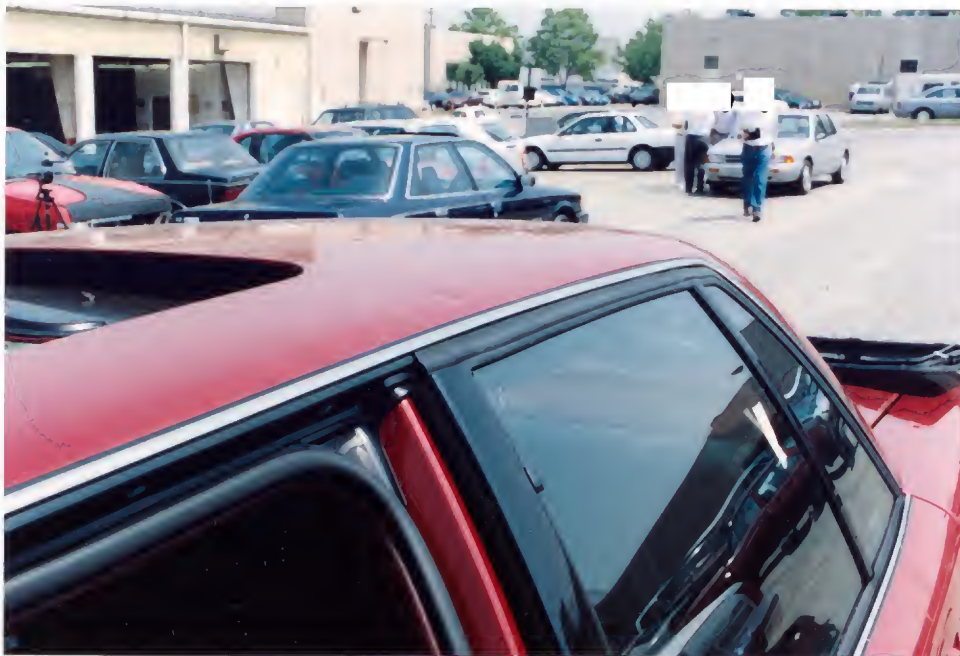
21. Induced deformation to roof at the left B-pillar.

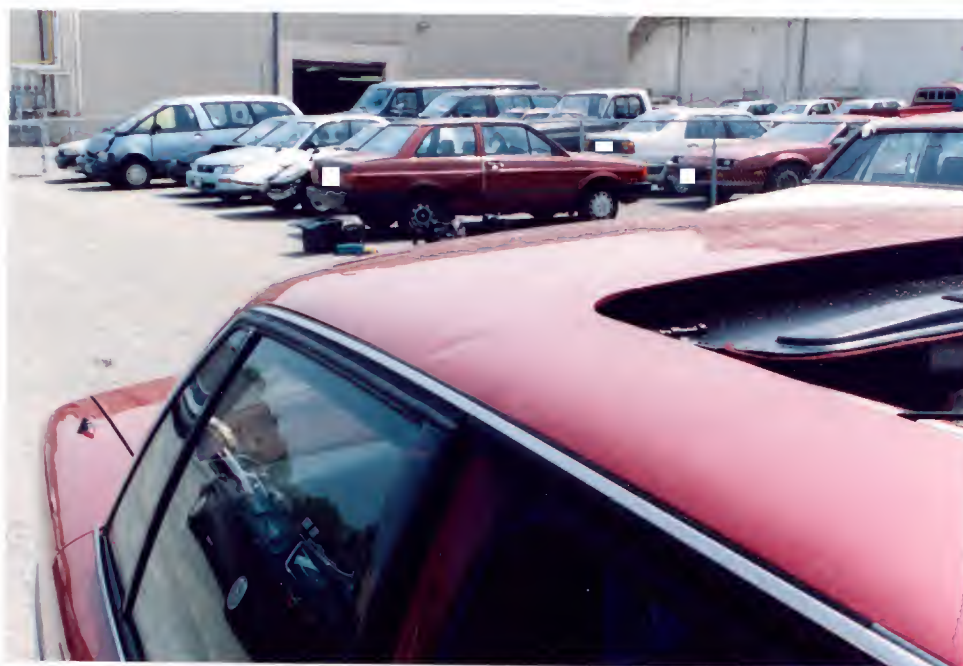
26. Induced deformation to the roof at the right B-pillar area.

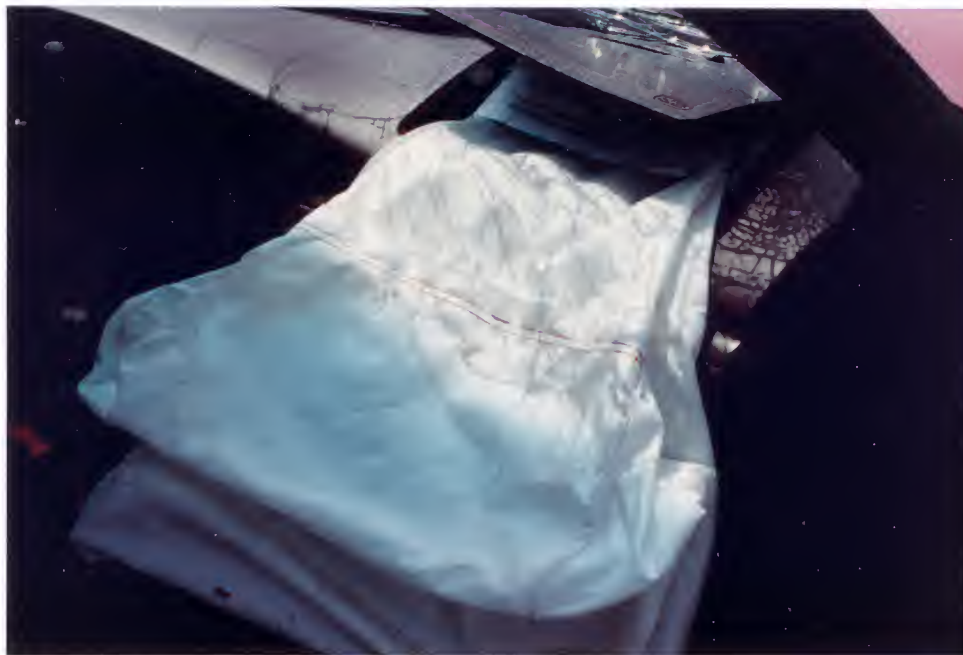
The rigid cover flap impacted and fractured the laminated windshield during deployment. The cover flap sustained 1.3 cm (0.5") of downward deflection at the right third sector that was due to contact with the contoured windshield. A thin sheet of Tyvek-like material was manufactured into the module assembly and was positioned between the interior surface of the module and cover flap which acted as a protective liner for the folded air bag (refer to Photograph No. 42). A bar coded label was affixed to the right side of the passenger side air bag module assembly which identified the unit with the following alpha-numeric sequence:

40. Passenger side air bag module cover flap.

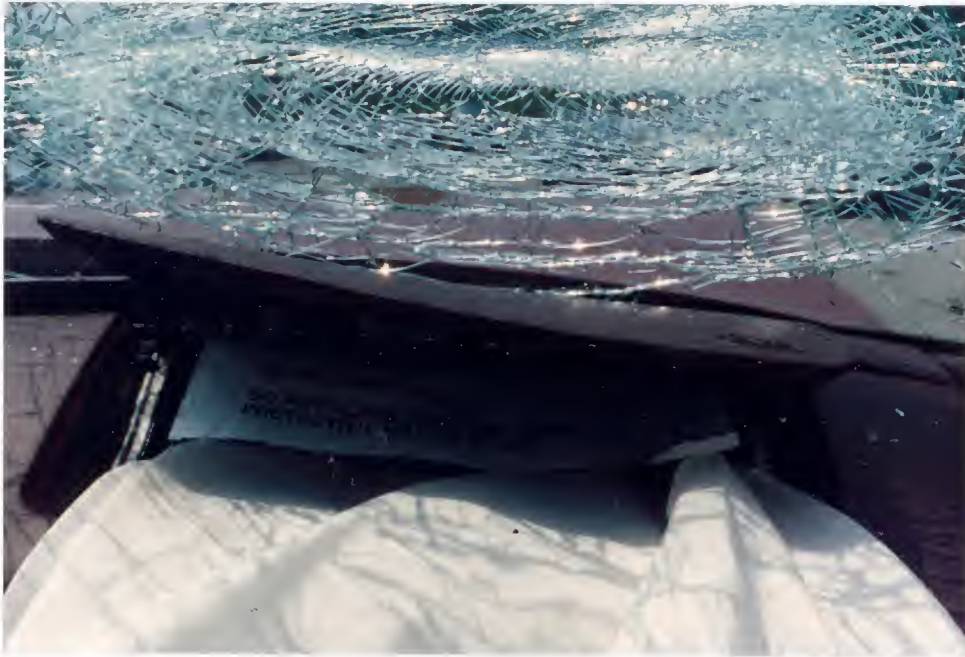
As a result of windshield contact, the module cover flap was abraded over the leading edge and front third area of the flap. In addition to the abrasions, the right third area of the flap was deformed in a downward direction 1.3 cm (0.5"), probably due to the contact with the curvature of the windshield. The expanding passenger side air bag probably contacted the interior rear view mirror and displaced the right side of the mirror in an upward direction. The trim panel at the trailing edge of the instrument panel adjacent to the windshield was displaced forward and upward from deployment of the passenger air bag module cover flap (refer to Photograph No. 41). The upper surface of the passenger side air bag exhibited burgundy vinyl transfer marks which resulted from expansion of the bag against the internal surface of the module cover flap. Within the vehicle were numerous white powder transfers that were associated with the deployment. A small white powder transfer was located on the vinyl trim panel at the apex of the B-pillar and the roof side rail. The same substance was also noted on the leading edge of the stowed right sunvisor at 43.8-47.0 cm (17.25-18.5") right of the vehicle's centerline. The visor also had a depression located 41.9-46.4 cm (16.5- 18.25") right of center

At impact with the Ford Ranger pickup truck, the supplemental driver and passenger side air bag system deployed. The leading edge of the passenger side air bag module cover flap impacted her right third through fifth fingers which resulted in comminuted fractures of the distal right third, fourth, and fifth metacarpals with displacement to the right, comminuted intra-articular fractures of the middle phalanx of the right fifth digit and distal phalanx of the fourth digit, and open lacerations of the volar aspect of the right fourth and fifth digits. There was no evidence of passenger hand to the instrument panel or module cover flap. The cover flap contact in combination with the deploying air bag, displaced her hand in an upward and rearward direction. It should be noted that there was no hand contact with the windshield which was fractured by the cover flap. Numerous whitish -type transfers were noted to the headliner and side rail trim within the vehicle. Although none of these transfers appeared to be tissue, the transfers were probably residue that resulted from deployment of the SRS.

41. Leading edge of the module cover flap.

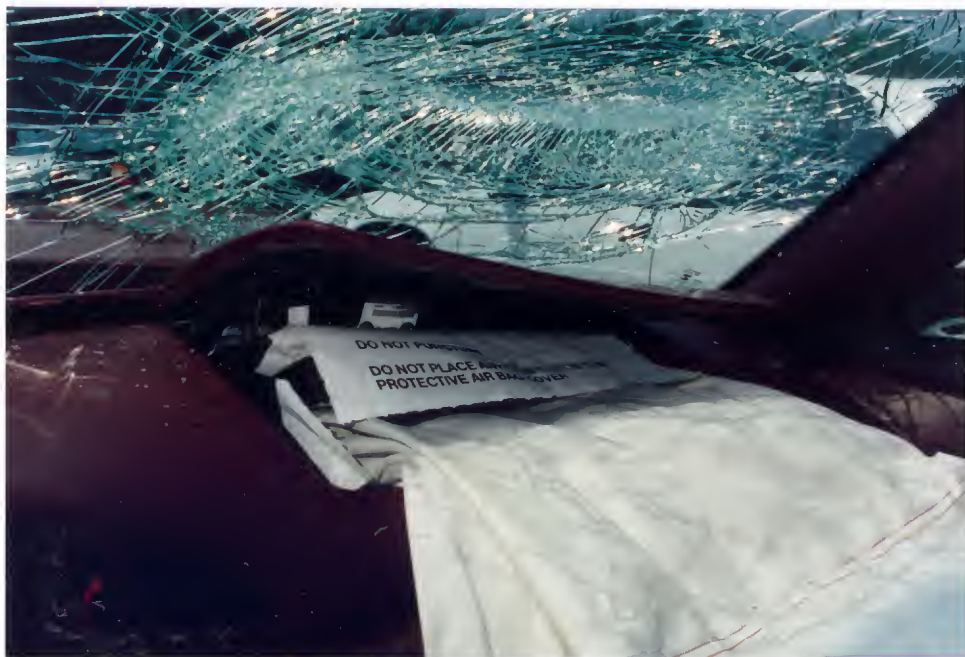
In addition to the DERM readout, the General Motors representative indicated that the passenger side air bag module cover flap typically does not impact the windshield as it did in this crash related deployment. He noted that when ambient temperatures exceed 21 degrees C (70 degrees F), the gas generators have a tendency to produce more gas, therefore resulting in a more aggressive deployment. This aggressive deployment probably resulted in cover flap contact with the windshield. At the time of the crash, the ambient temperature was approximately 24 degrees C (mid 70's degrees F). The Oldsmobile was apparently parked for an unknown period of time prior to the crash which probably resulted in an interior temperature which exceeded the ambient temperature.

42. Module flap and resultant windshield contact damage.

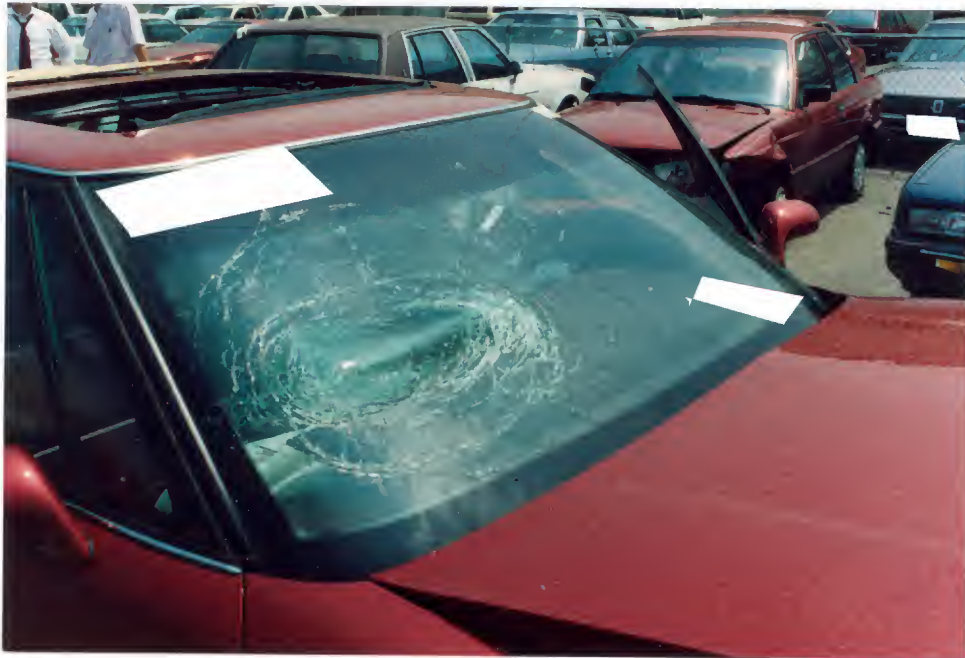
43. Exterior view of the windshield damage.

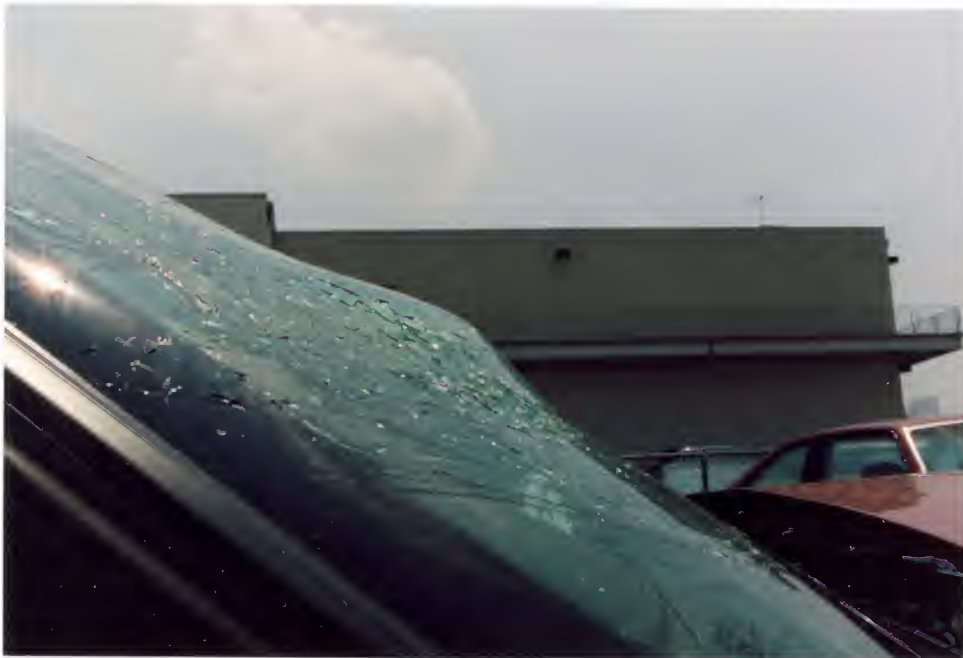
44. Perpendicular view showing the outward displacement of the windshield.

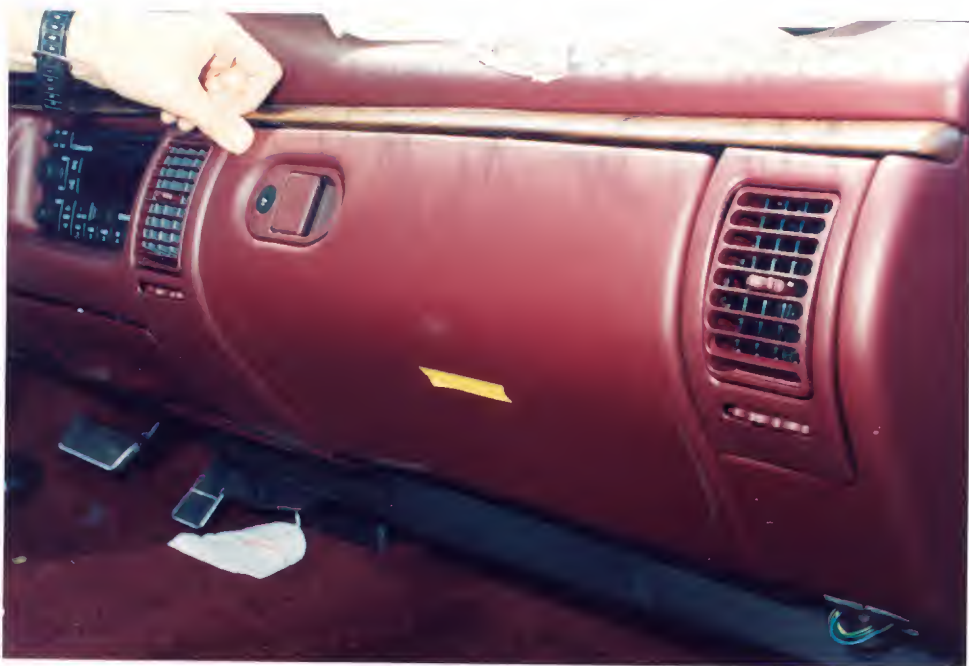
As a result of the deployment of the passenger side air bag, the glove box door opened and probably impacted the passenger's knee and or leg. A scuff with a small diameter gouge was noted to the top edge of the door with a body fluid stain (blood) adjacent to the gouge. There were no injuries reported to the lower extremities of the passenger, therefore the blood stain on the glove box door probably occurred from the hand post-crash. She came to rest in an upright posture in the passenger seat.

46. Possible knee scuff to the glove box door.

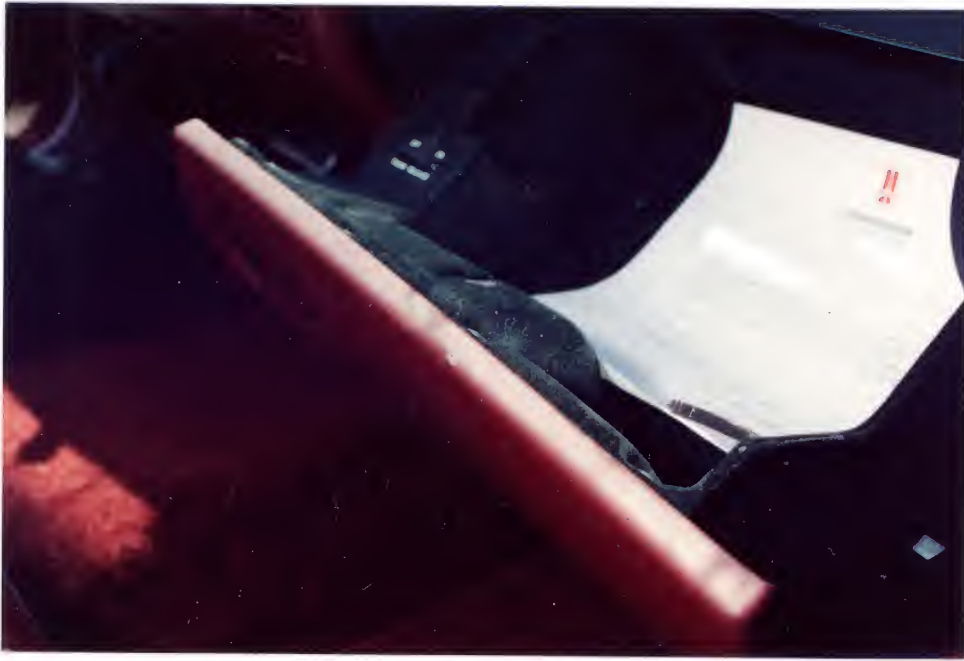
which probably resulted from contact by the volar aspect of the passenger's right hand. A vertically oriented 3.8 cm (1.5") white powder-type scuff was located on the apex of the right mid A-pillar. Another white powder-type mark was located on the leading edge of the passenger roof assist grip (refer to Photograph No. 51). A white powder transfer mark was noted on the headliner adjacent to the B-pillar 10.8-13.3 cm (4.25-5.25") inboard of the side rail (refer to Photograph No. 52). The lower surface of the passenger side air bag exhibited several 1.9 cm (0.75") body fluid (blood) stains which probably occurred post-event as the passenger remained in the vehicle and the bag deflated. The glove box door was found fully open and would not latch, although it was not deformed. A possible knee scuff was located on the glove box door 19.7-22.5 cm (7.75-8.875") right of the left edge and 12.7-14.6 cm (5.0-5.75") below from the mid panel/upper panel juncture (refer to Photograph No. 46). The vinyl fabric at the top edge of the glove box door was gouged 24.1-24.4 cm (9.5-9.625") right of the left edge (refer to Photograph No. 47). Body fluid was present around gouge.

47. Gouge to the top edge of the glove box door.

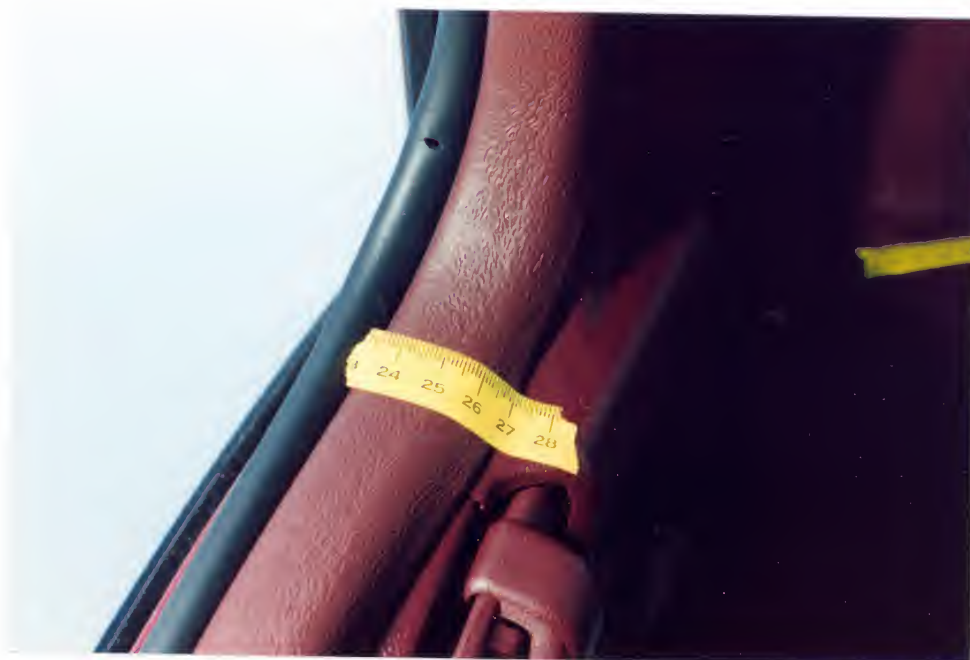
50. White powder transfer at the apex of the right B-pillar/side rail juncture.

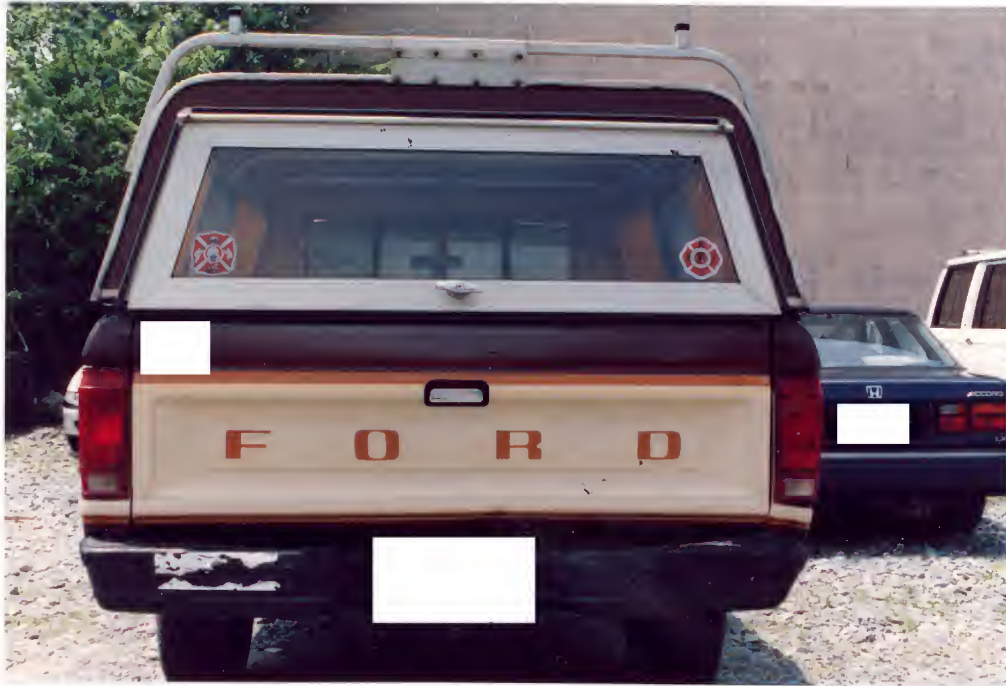
The 1983 Ford Ranger sustained full-width direct contact damage of 153.0 cm (60.25") to the lower portion of the rear bumper. The rear bumper was an original equipment manufacture (OEM) type step bumper with a ball hitch bolted to the mid point. Maximum crush was 7.3 cm (2.9") located on the lower right corner area. The crush profile was as follows: $C_1=5.1$ cm (2.0"), $C_2=2.8$ cm (1.1"), $C_3=1.5$ cm (0.6"), $C_4=1.9$ cm (0.75"), $C_5=5.1$ cm (2.0"), $C_6=7.3$ cm (2.9"). The vehicle damage profile is documented in Photograph Nos. 55- 58. The hood of the Oldsmobile engaged against the lower tailgate of the Ford Ranger, however, there was no contact damage to the tailgate. Paint transfers were noted to the hood face of the Oldsmobile from tailgate contact. Minor right frontal damage resulted to the Ford Ranger from its subsequent impact sequence with the stopped Nissan Pathfinder (vehicle #3). The damage consisted of bumper deformation at the right corner, right headlight and grille damage, and right front fender crush.

57. Rear view of the distributed direct contact damage.

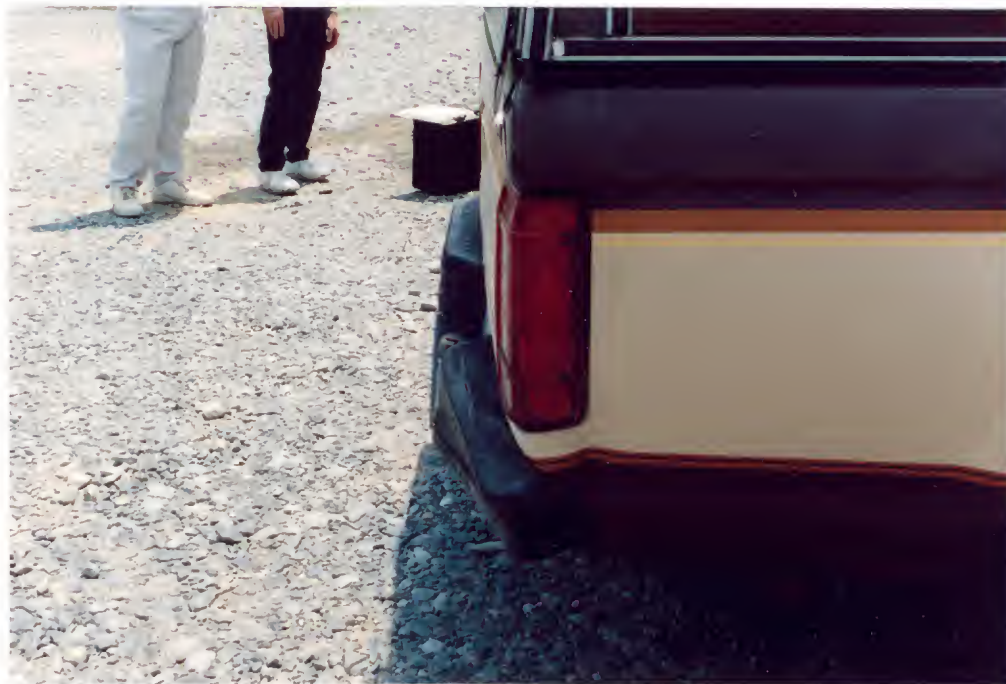
58. Perpendicular view of the right rear corner showing the extent of crush.

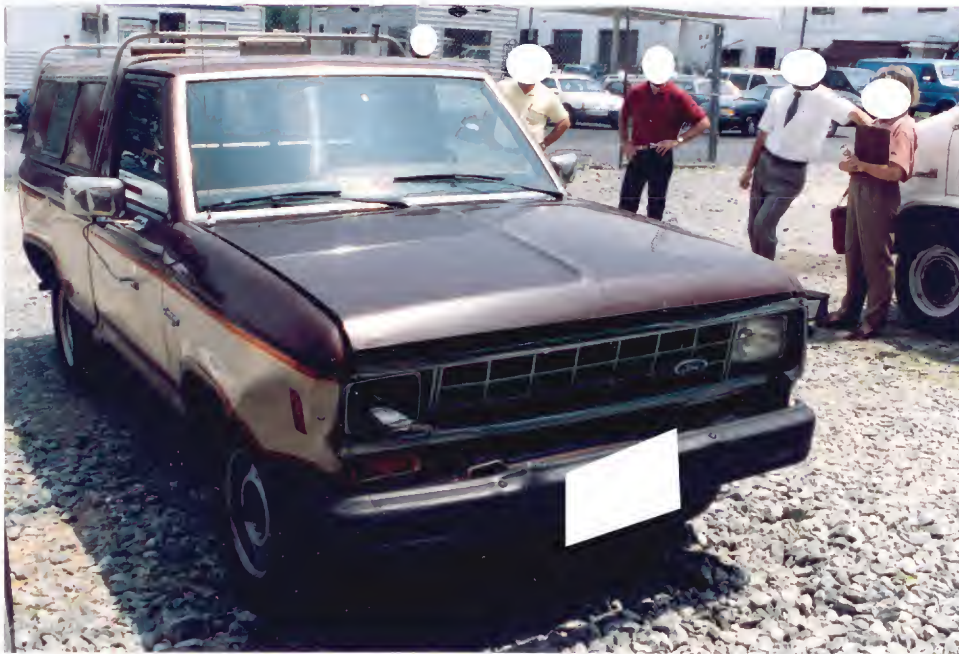
The impact displaced the Ford Ranger pickup truck in a forward direction where it impact the stopped 1988 Nissan Pathfinder (vehicle #3). The subsequent impact sequence resulted in impact forces of 12 o'clock and 6 o'clock for the Ford and Nissan respectively. Frontal damage to the Ford Ranger consisted of deformation to the right side bumper, headlamp, grille, and right front fender. The rear of the Nissan Pathfinder sustained minor damage.

60. Subsequent frontal damage that resulted from contact with vehicle #3.
